LAND USE AND RIVER SYSTEMS: IMPACTS OF SUBURBAN RESIDENTIAL
DEVELOPMENT ON CHANNEL STABILITY AND WATER SUPPLY, OAK RIDGES
MORaine, SOUTHERN ONTARIO

A THESIS SUBMITTED TO
THE FACULTY OF GRADUATE STUDIES
IN PARTIAL FULFILLMENT OF THE REQUIREMENTS
FOR THE DEGREE OF
MASTER OF SCIENCE

GRADUATE PROGRAM IN GEOGRAPHY

YORK UNIVERSITY

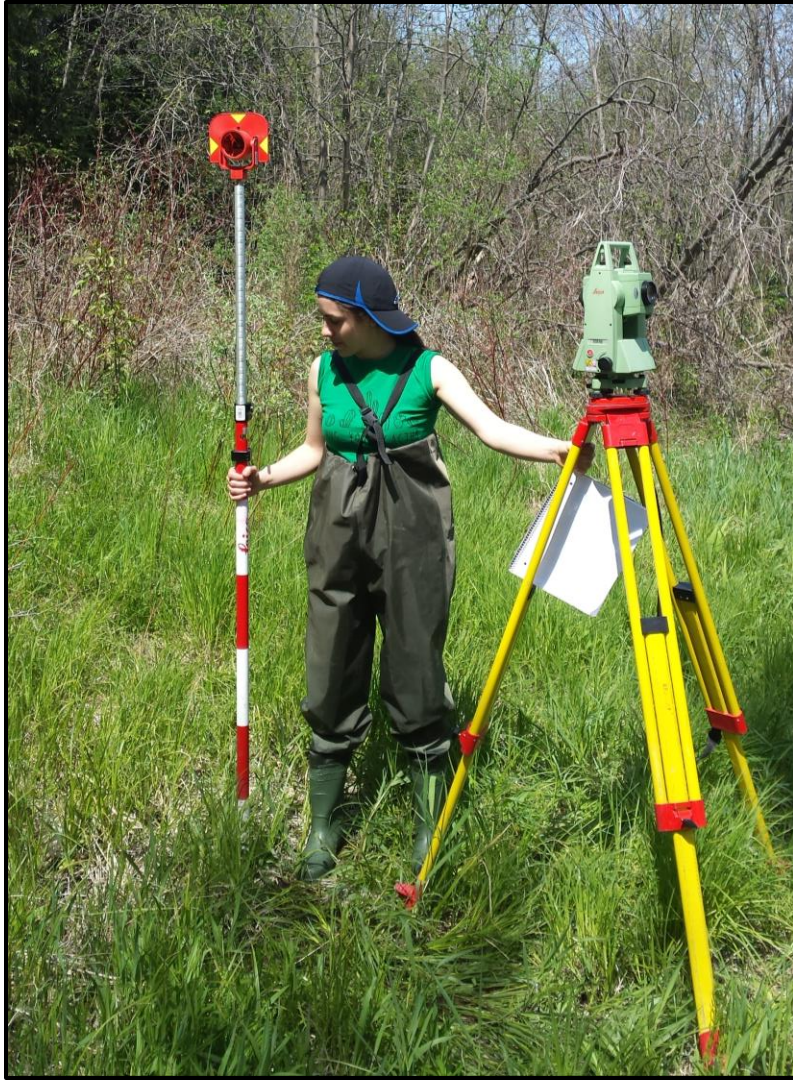
Figure 3.5: Total survey station and equipment

A two-part topographic survey of the channel reaches was conducted using a total station. An image of this can be seen in Figure 3.5. Firstly, using the survey equipment, a cross-sectional profile was created for each of the six sites. These cross-sections were located at the downstream end of the reaches. Latitude, longitude, and elevation was collected starting from approximately 1 m from the edge of the streambank, then down the banks, through the channel, up the opposite bank, and to approximately 1 m from the edge of the opposite bank. Since there is vagueness in the definition of where a streambank begins and a stream ends (Curran and Hession, 2013), the level of detail of these cross-sectional surveys was of the utmost importance to provide a detailed image of cross-sectional shape. As such, measurements were taken approximately every

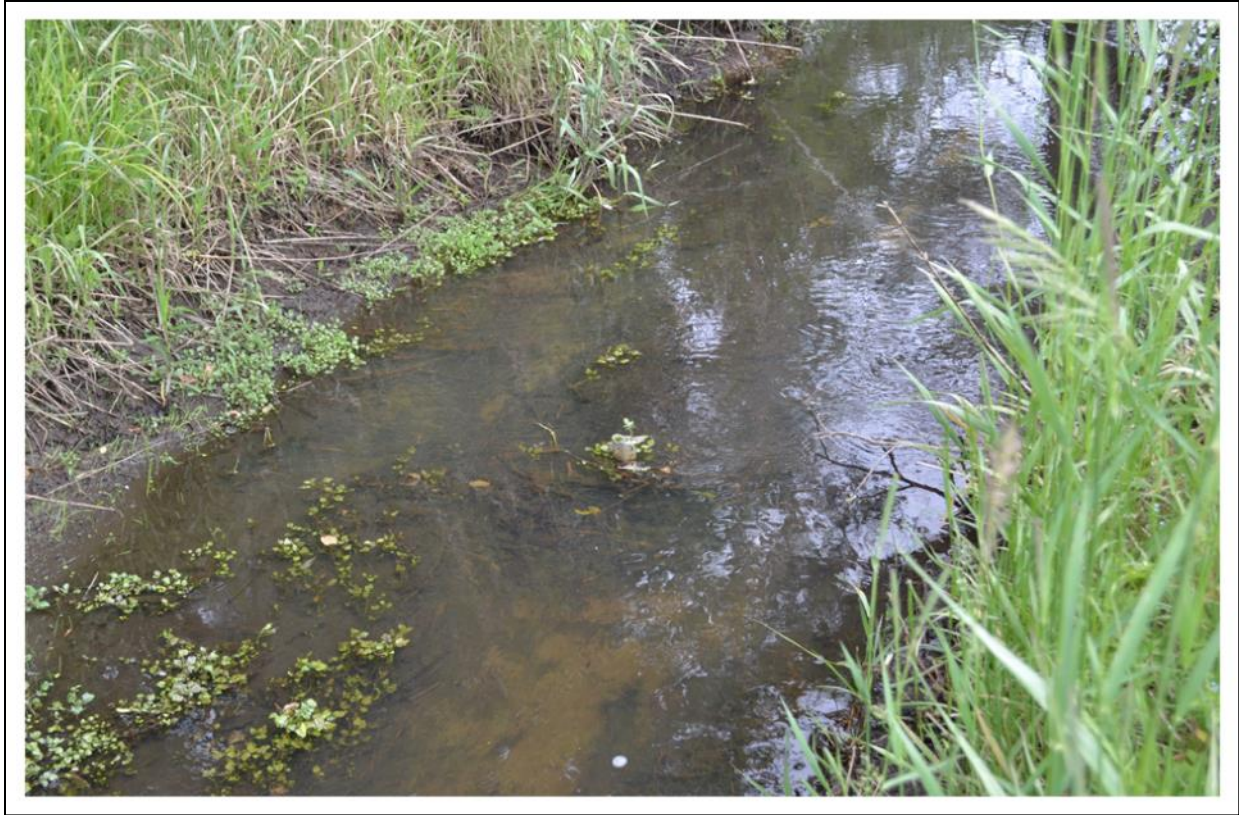
Figure 3.19: Datalogger emplacement at Caledon East upstream site

The most likely explanation for the flow anomaly is debris build up on the water level datalogger. As can be seen in Figure 3.19, the channel at CU is small and considerably vegetated. More than any other site, a great deal of organic debris flows through the cross-section regularly. The build up of organic debris around the datalogger and the post it was secured to on the channel bed could cause the pressure readings to be deceptively high, unrepresentative of the actual water level. This could be exacerbated if the built up organic material additionally caused an accumulation of bed sediment and organic matter just upstream and potentially overtop the datalogger. At some point during the field season, the datalogger was swept of debris to remove the build up of organic matter and other materials from the device, though the date of this cleaning was not noted.

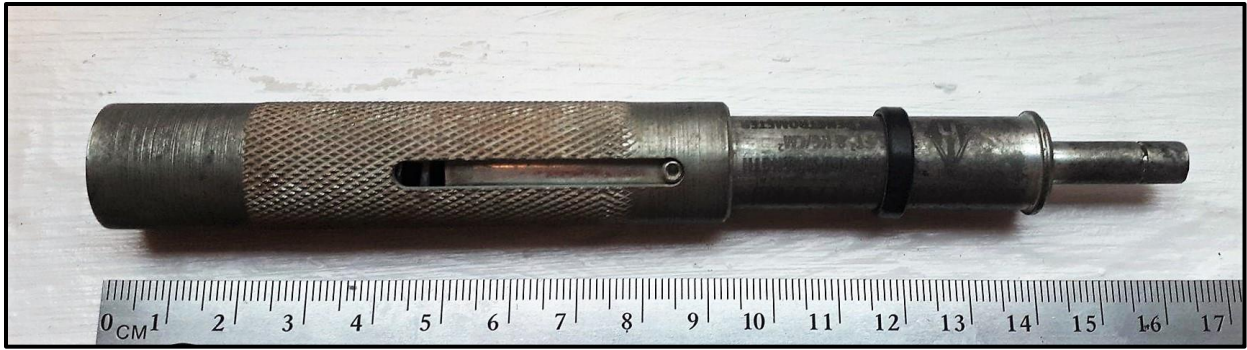
Figure 3.20: Pocket penetrometer

Another technique was employed in an attempt to bring quantification of bank stability into the project. Soil strength was measured using a pocket penetrometer, shown in Figure 3.20, on both sides of the channel at the furthest downstream point in each of the reaches, i.e., at the location of the cross-section. Measurements were taken at the top just inside of the bank, mid bank, and near the water surface. These bank strength measurements were repeated every 10 cm upstream a total of twenty-one times, hence, covering the bank soil strength of the 2 m furthest downstream in each of the six reaches. Measurements were taken once a month a total of four times over the study span between June and September. While the use of penetrometers is widely used for soil strength measurements, this technique has not been widely employed across research of bank erosion and stability. This work made use of soil strength measurements in an attempt to

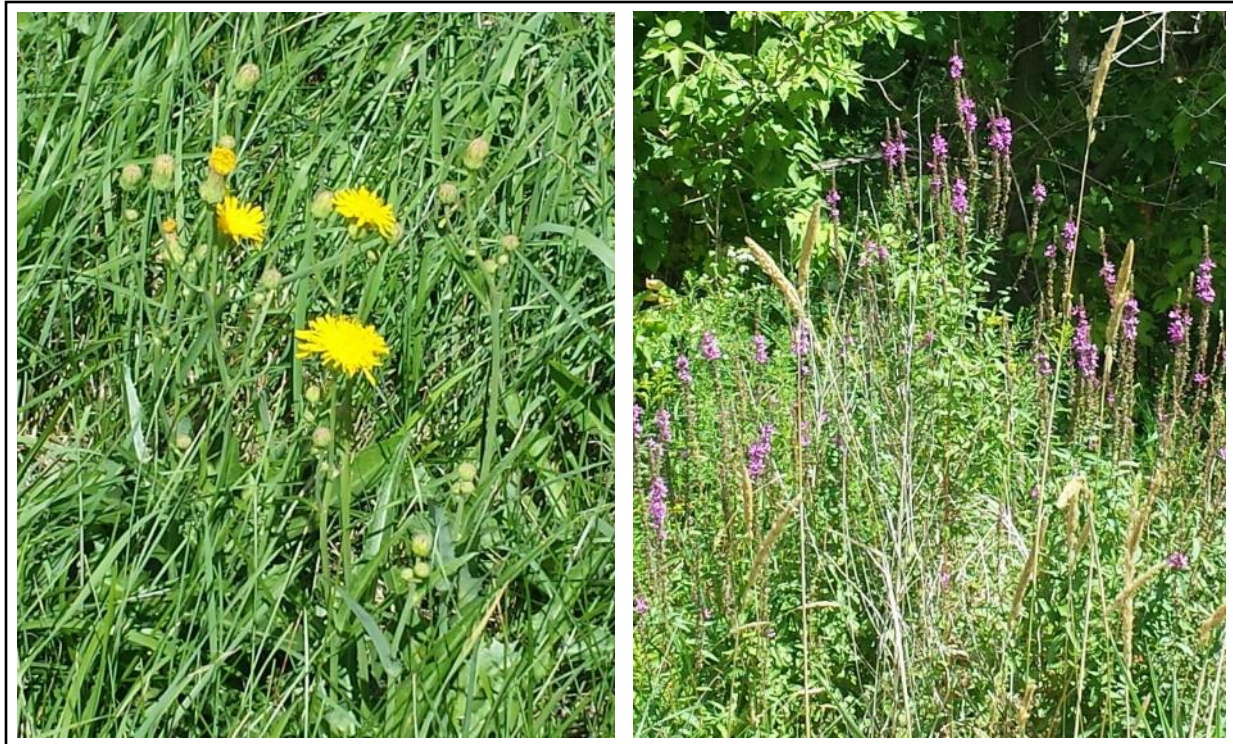
Figure 4.10: Common dandelion (*Taraxacum officinale*), left, and purple loosestrife (*Lythrum salicaria*), right, at Caledon East upstream site

An important factor in the abundance of invasive vasculars at the CU site stems from its location on private property. While the right bank consisted of dense tree cover and understory vegetation, with trees beyond the 5 m zone for classification, the left bank along the extent of the reach was regularly mowed and maintained by the property owner. While vegetation in the

immediate bank area (1.0–1.5 m in from the channel) was usually left untouched, those grasses, sedges, and weeds beyond this thin buffer were mowed short to a few centimetres frequently over the study period. This regular disturbance could account for the noticeably higher proportion and abundance of invasive species at the downstream site compared to the upstream. As mentioned in section 2.5, disturbed areas promote the growth of invasive and ruderal species as they are quick to establish and outcompete native plants. At a glance, the fact that only 1/18 (5.6%) species identified in the riparian area of CD are not native to southern Ontario while nearly half of the identified species at CU, 6/15 (40.0%), were identified being invasive or non-native may give the impression that channel condition at the upstream site were causing bank instability and vegetation disturbance. If this were the case, the bank instability would allow for the establishment of invasive plant varieties. While disturbance along riparian corridors is often the product of erosive flow conditions and resultant bank instability, the difference in invasive and native plant compositions

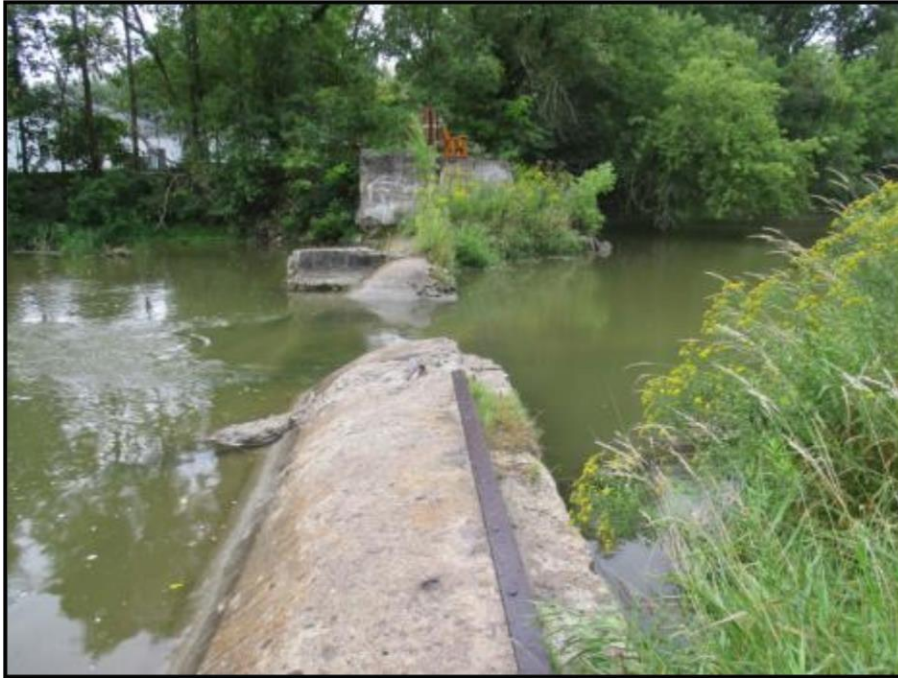
Figure 5.1: Dick's Dam, Bolton, upstream of Bolton downstream site

Data from BD show signs that the flow is possibly regulated in some way. For a time, the presence of a dam between the two sites was suspected to be causing complication in the data. In speaking directly with TRCA staff, including a planner, hydrogeologist, and technicians, it was concluded that the dam was notched some decades ago and since then has not had a significant impact on flow downstream. The dam is shown in Figure 5.1. The TRCA staff theorized that the only time the dam would have any impact at all would be during very high flows, and even then, the impact would be minimal. It is known that nine tributaries join the reach downstream of BU
